LANDSLIDES AND RELATED FEATURES

OF THE DERRICK CITY, PA. QUADRANGLE
by
John S. Pomeroy
1981
U.S. Geological Survey
OPEN FILE MAP 81-238 (H-12)

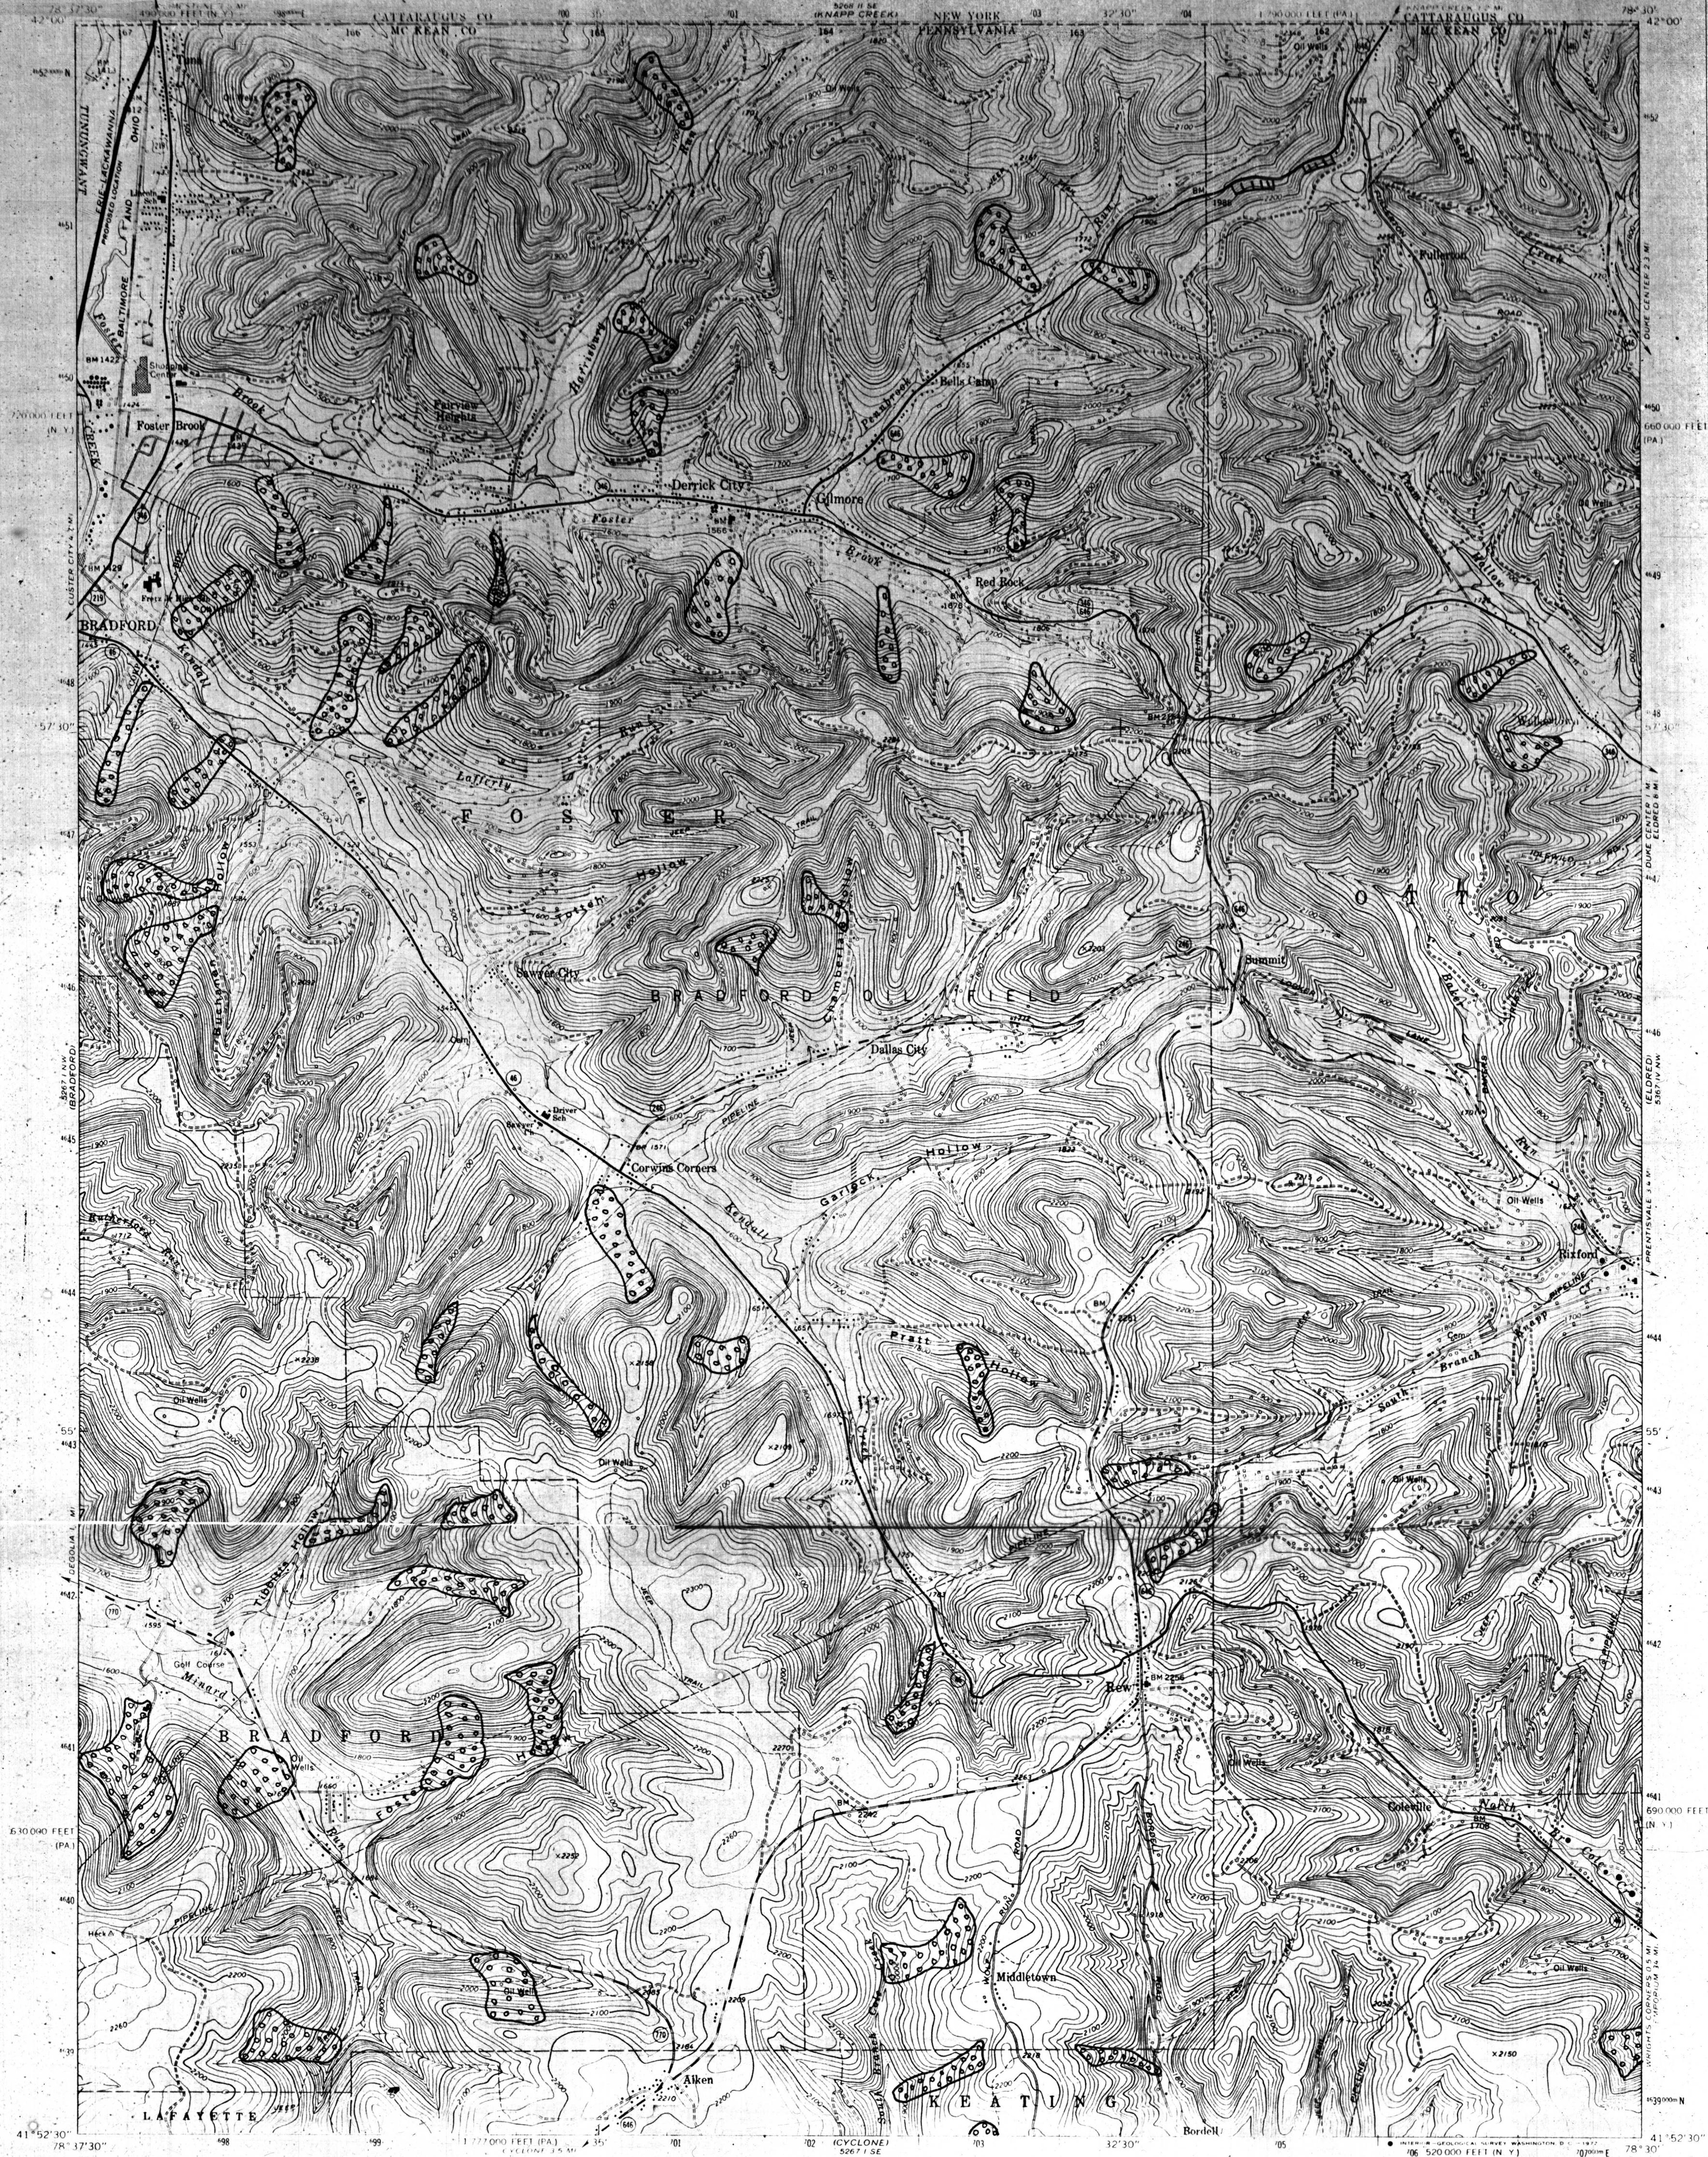
Landslides and related features interpreted
from aerial photographs:
1:78,000 (black and white) 1977
Photointerpretation and field check 1978-1979
This map has not been edited or reviewed
for conformity with Geological Survey
standards and nomenclature.

- ACTIVE OR RECENTLY ACTIVE LANDSLIDE**
Complex landslide composed of earthflow, debris
slide, earth and rock slump. Identified from
historical records, and from scars, debris and
other field evidence. Ground extremely unstable;
sliding accelerated by excavation, loading and
changes in drainage conditions. May include
areas with several active slides too small to
be shown separately. Questioned where doubtful.
May be shown with symbol (A) where difficult to discern.

- OLD LANDSLIDE**
Area of extensive hummocky ground caused by
earthflow and earth and rock slump. Lacks
clear evidence of active sliding. Relatively
stable in natural, undisturbed state,
generally not affected by small structures properly
sited in areas away from the edge of the toe;
can be reactivated by extensive, rapid exca-
vation, loading, and changes in ground water and
surface water conditions. Area of old landslide
probably includes recent ones not identified
from field evidence or otherwise documented.
Upslope boundary of landslide generally defined
by modified scarp, but downslope (toe) may be
gradational and not well defined. Questioned
where doubtful.

- COLLUVIAL SLOPE**
Valley wall along major streams with slope as
steep as 40° (85%); stony, clayey silt soil up
to 50 ft. (15 m) thick; commonly buttressed by
a terrace or bench at the toe of the slope; very
susceptible to sliding by cutting of toe area,
removal of terrace or bench, and overloading;
slide commonly activated without apparent cause.

- AREAS SUSCEPTIBLE TO DEBRIS FLOWS AND DEBRIS
AVALANCHES**
Primarily shallow, narrow ravines and chutes with
accumulation of stony colluvium generally 10 ft.
(3 m) or less in thickness; susceptible to rapid
movement during intense rainfall. Most ravines
and chutes designated show evidence of former
debris flows and avalanches. Symbol A design-
ates historical debris flow or debris avalanche.

- AREAS SUSCEPTIBLE TO ROCKFALL**
Steep, locally vertical, natural and man-made
slopes and cliffs, 15 ft. (4.5 m) or more high;
formed dominantly of sandstone, limestone, sandy
shale, mudstone and claystone. Interbedded mud-
stone, claystone and shale weather rapidly leaving
sandstone and limestone rock faces unsupported.

- SOIL AND ROCK SUSCEPTIBLE TO LANDSLIDING**
Soil and rock similar to that involved in land-
slides elsewhere in map area; primarily areas
underlain by claystone, mudstone and shale
associated with other rock types. Rock weathers
rapidly on exposure forming clayey soil highly
susceptible to sliding. Includes coves (U-shaped,
shallow valleys) containing thick layers of clayey
soil that are very susceptible to sliding where
excavation breaks continuity of slope and where
overloaded by artificial fill.

- AREAS LEAST PRONE TO LANDSLIDES**
Map areas in which no patterns or symbols are shown;
primarily valley floors, ridge tops and broad
benches; modification by excavation and fill may
lead to local landslides.
Includes slopes where landslides are sparse.

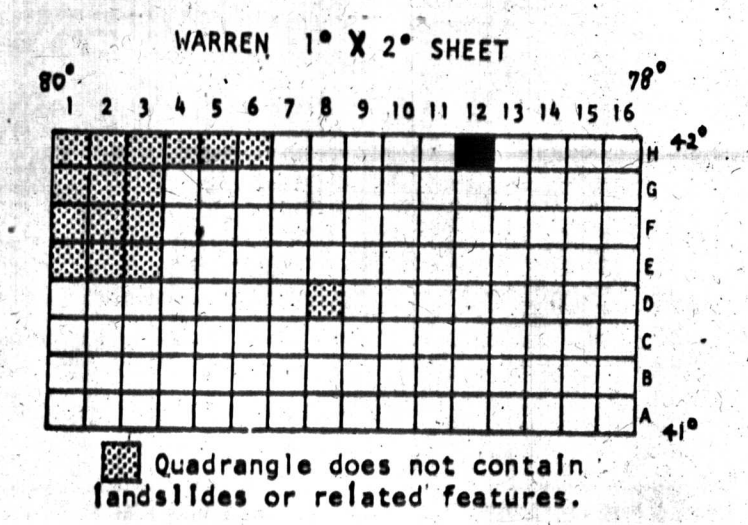
The first five digits of the open file number designate the
specific 1:250,000 scale map sheet of which this quadrangle
is a part. The last two digits designate the position of the
quadrangle in a subdivision of the 1:250,000 scale map based
on rows and tiers shown in the diagram to the right. The
location of this quadrangle is shown by the black square.
